# MANAGEMENT ASBESTOS SURVEY REPORT

1st Park Street Scout Hut  
Rear of 29-31 Birchwood Way  
Park street  
Herts  
AL2 2SU

1st Park Street Scout Group  
J027272  
24 Oct 2016  
28 Oct 2016  
1

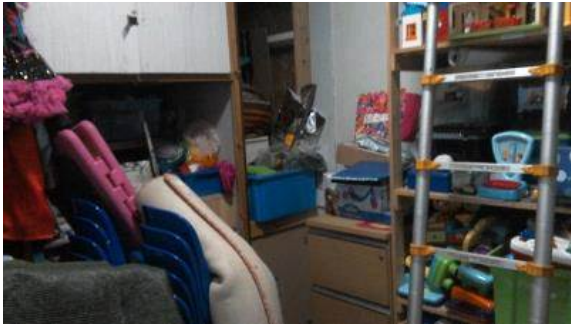
0.01 - Store room	AX001072 - 2	S	Cement Wall panels	Asbestos Cement	12m <sup>2</sup>	Occasionally likely to be disturbed	Low Damage	Surface Sealed	Chrysotile	4	Manage & Label

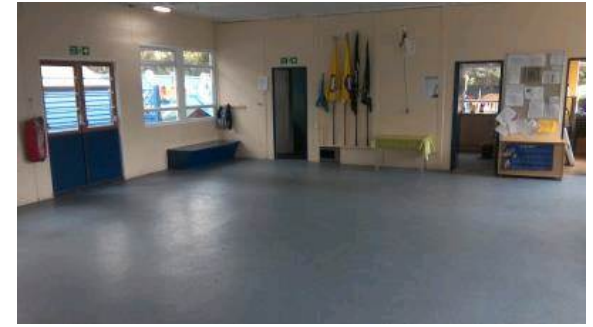
0.03 - Main hall	AX001072 - 5	SP	Cement Wall panels	Asbestos Cement	30m <sup>2</sup>	Occasionally likely to be disturbed	Low Damage	Surface Sealed	Chrysotile	4	Manage & Label

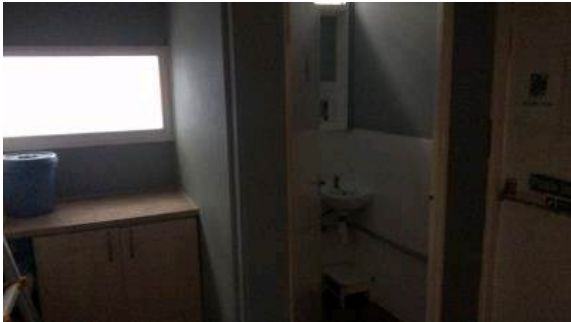
0.04 - Toilets	AX001072 - 7	SP	Cement Wall panels	Asbestos Cement	16m <sup>2</sup>	Occasionally likely to be disturbed	Low Damage	Surface Sealed	Chrysotile	4	Manage & Label

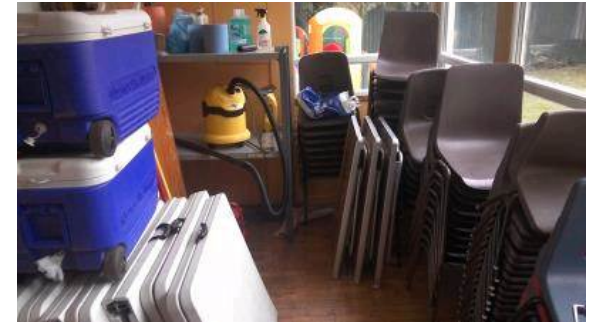
0.06 - Store	AX001072 - 12	SP	Cement Wall panels	Asbestos Cement	12m <sup>2</sup>	Occasionally likely to be disturbed	Low Damage	Surface Sealed	Chrysotile	4	Manage & Label

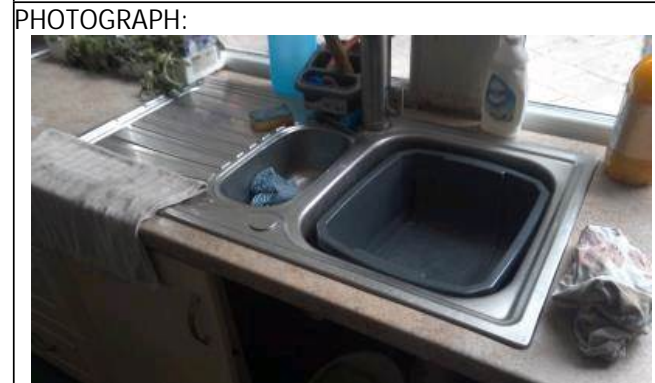
LOCATION:  
0.05 -  
Kitchen

SAMPLE ID:  
AX001073 -  
10

SAMPLE DESCRIPTION:  
Bitumen pads to sink/drain

ASBESTOS:  
No Asbestos identified

RECOMMENDATION:  
No Action Required

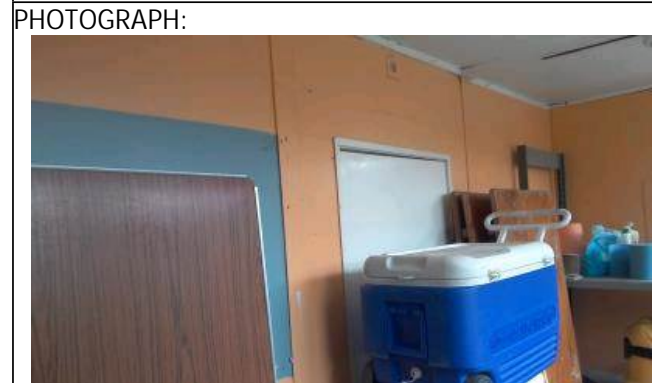
LOCATION:  
0.06 -  
Store

SAMPLE ID:  
AX001072 -  
12

SAMPLE DESCRIPTION:  
Cement Wall panels

ASBESTOS:  
Chrysotile

RECOMMENDATION:  
Manage & Label

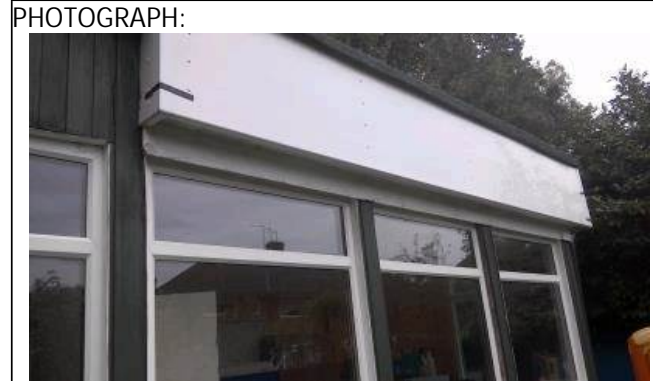
LOCATION:  
EXT -  
Externals

SAMPLE ID:  
AX001074 -  
13

SAMPLE DESCRIPTION:  
Insulating board fascia panels to main roof line

ASBESTOS:  
Chrysotile + Amosite

RECOMMENDATION:  
Manage & Label

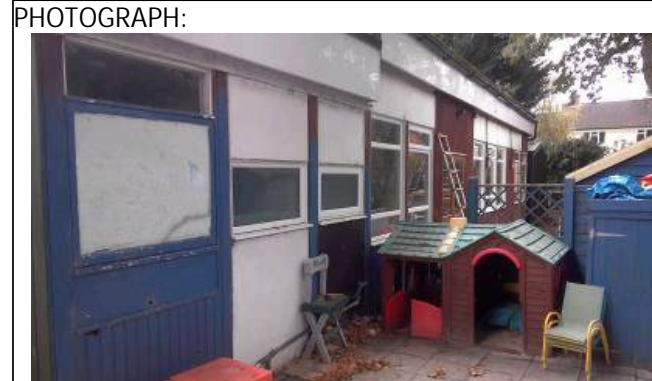
LOCATION:  
EXT -  
Externals

SAMPLE ID:  
AX001074 -  
14

SAMPLE DESCRIPTION:  
Insulating board Panels above and below windows

ASBESTOS:  
Chrysotile + Amosite

RECOMMENDATION:  
Manage & Label

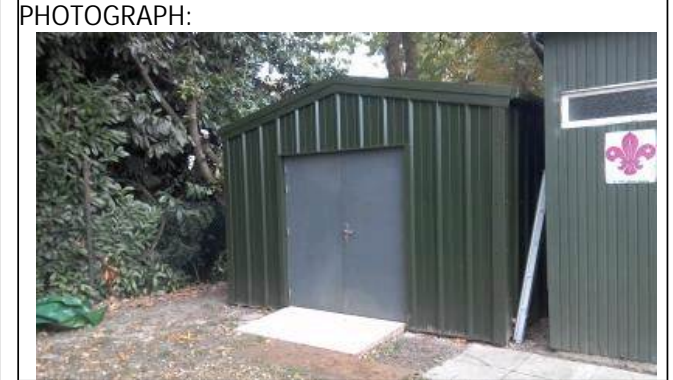
LOCATION:  
EXT -  
Externals

Location	Description	Recommendations
Building: 1st Park Street Scout Group hut		
EXT - Externals	No access within store- no keys available at time of survey	Inspect prior to works

SAMPLE ID:  
NO ACCESS

SAMPLE DESCRIPTION:  
No access within store- no keys available at time of survey

ASBESTOS:  
Unknown

RECOMMENDATION:  
Further Investigation required
